STS-106
FLIGHT READINESS REVIEW

August 29, 2000

Ground Operations

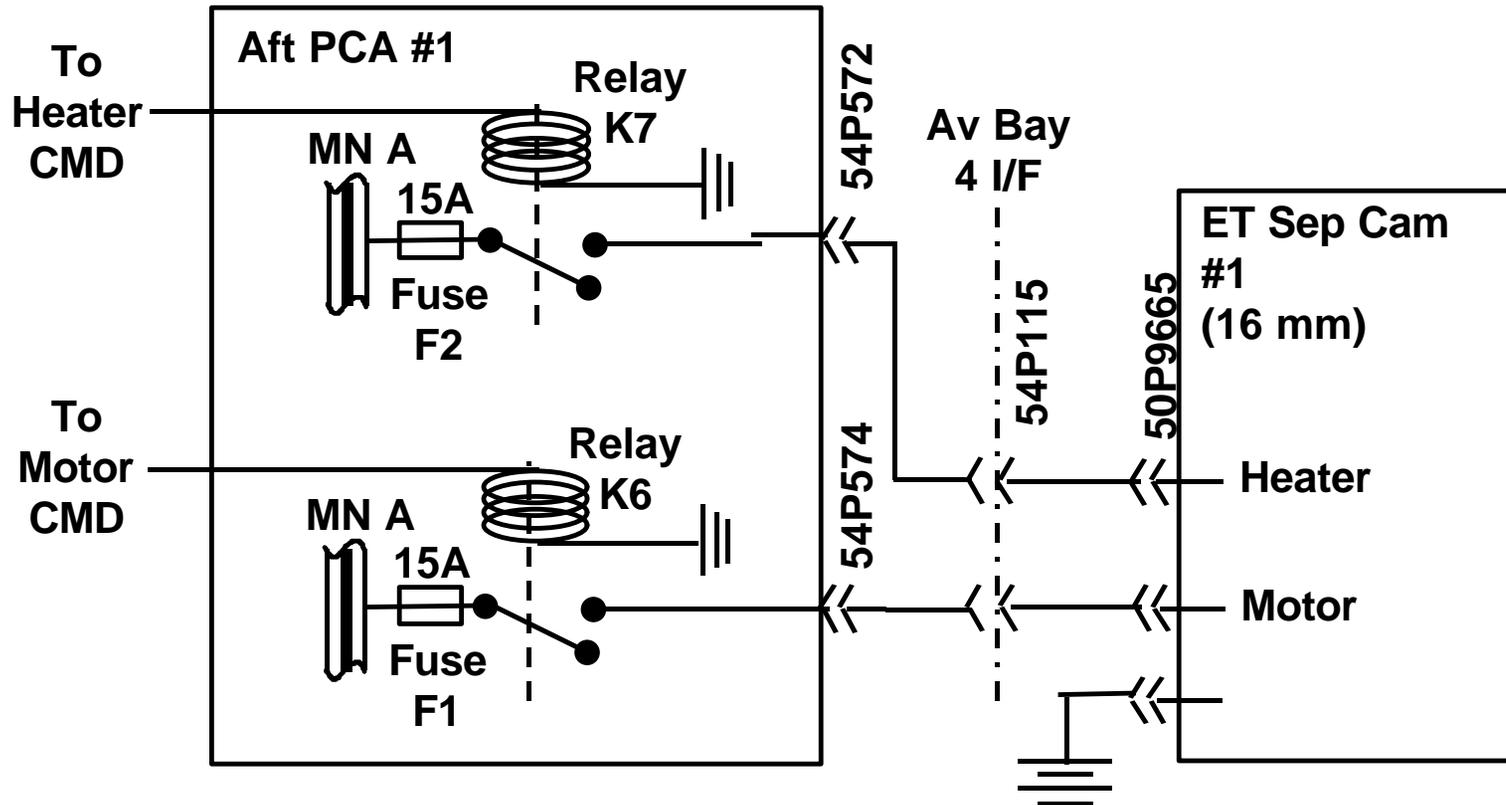
ET Separation Camera #1 Simplified Schematic

- Title: ET Separation Camera #1 Blown Fuse
- Observation
 - During the performance of ground turnaround checkout of the ET separation camera #1 (16 mm type) motor power voltage read 0 volts should have been 27.0 to 32 volts dc
 - Subsequently identified that Aft PCA #1 Fuse #1 was OPEN, after replacement of this fuse the circuit functioned nominally
- Concerns
 - Inadvertent shorting of wiring circuits could affect electrical system performance
 - Potential loss of data from ET Separation Camera

- Title: ET Separation Camera #1 Blown Fuse (Cont'd)
- Discussion
 - ET Sep Camera circuit is now tested using a GSE Camera Test box in place of the GFE Camera
 - Unit is equipped with a 0.5 Amp fuse for circuit protection
 - Unit is equipped with a 10K Ohms resistor for heater load simulation
 - Ground checkout is performed in the OPF Flow and the actual ET Sep Camera's are not installed until the VAB operations
 - There have been 3 previous occurrences of this type of problem with ET Sep Camera fuses being blown and documented as UA's (2 on OV-102, and 1 on OV-104)
 - Previous Most Probable Causes were related to GSE test configuration decade box type (before Camera Test Unit creation)

- Title: ET Separation Camera #1 Blown Fuse (Cont'd)
- Actions Taken
 - IPR 106V-0040 was taken to document the 0 voltage condition and to perform initial troubleshooting of the problem
 - Gained access to Aft AV Bay 4 to inspect the Fuse #1 of Aft PCA #1
 - Identified Fuse #1 as OPEN, removed and replaced fuse, routed fuse to MAB Lab for failure analysis
 - MAB Lab X-ray and dissection concluded fuse failure was due to current overload
 - Circuit retested at 29.2 Vdc when energized after replacement of fuse #1

- Title: ET Separation Camera #1 Blown Fuse (Cont'd)
- Actions Taken (Cont'd)
 - Continuity, Isolation and Hi-Pot Testing was performed on the vehicle portion of this circuit from the camera I/F connector to the Aft PCA #1
 - No discrepancies were identified with any of the vehicle wiring
 - End to End test performed with different S/N Camera
 - Data from JSC Camera Troubleshooting was as follows
 - Camera did not take pictures during STS-101 Flight
 - Inspection of camera revealed no evidence of film jams or film chips
 - Camera was operated with remaining roll of film and another new roll of film with no anomalies

- Title: ET Separation Camera #1 Blown Fuse (Cont'd)
- Actions Taken (Cont'd)
 - Data from JSC Camera Troubleshooting was as follows (Cont'd)
 - Camera motor operating current was 2.92 amps at 28 Vdc (Nominal)
 - Camera current at startup was measured greater than 15 amps
 - Max current was 18 Amps for less than 20 ms at startup
 - Fuse Spec and design allows for up to 70A for < 750 ms
 - Heater circuit was checked and verified operational
 - All three ET Sep Cameras were checked and tested normally

- Actions Taken (Cont'd)
 - STS-106 Camera Troubleshooting/Retest/Verification
 - Next flight camera was operated for 6 seconds with no anomalies
 - Heater circuit was checked and verified operational

- Possible Causes
 - **Wiring – Connectors**
 - Intermittent short in the power path due to wiring or connector/pin contact issue
 - Ruled out by wire inspection (80%), wiring isolation and hi-pot testing post flight
 - Intermittent short within A-PCA-1 from the output of K6 Relay to vehicle ground via the LRU
 - Ruled out by good post flight retest and no history of this failure type in program

- Title: ET Separation Camera #1 Blown Fuse (Cont'd)
- Possible Causes (Cont'd)
 - **Camera Malfunction**
 - Camera Heater Failure – freezing the motor mechanism and then causing the fuse to be subjected to a current overload and open
 - Ruled out by the lack of film pieces/debris in camera post flight
 - Intermittent, High Current – Rapid Duration Short inside Camera Motor
 - Undetectable duration spike less than 20 ms
 - Vehicle current data sample rate is 50 times per second
 - Event is consistent with MAB Lab Fuse failure analysis
 - Melted conductor in narrow areas

- Possible Causes (Cont'd)
 - **Environmental Conditions**
 - Environmental conditions from repeated thermal cycles (CRYO Tanking) caused the camera film to stick/bind, resulting in increased current at camera startup and failure of the fuse
 - Ruled out by design, de-rating of fuse, and lack of film debris in camera post flight
 - **In-Rush Startup Current**
 - Nominal In-Rush start up current of 18 Amps degraded fuse over several cycles/missions
 - Ruled out by design and de-rating of fuse size
 - **Test Failure**
 - Fuse opened during last flow camera checkout due to overload
 - Ruled out by improved GSE camera test unit/set-up with 0.5 amp fuse

- Title: ET Separation Camera #1 Blown Fuse (Cont'd)
- Most Probable Cause
 - **Camera Malfunction**
 - Intermittent, High Current – Rapid Duration Short inside Camera Motor
 - Some graphite debris or other conductor within camera motor provided a momentary short of power to ground at start-up which caused an electrical overload of the 15 amp fuse
 - Short condition was of sufficient magnitude to eliminate itself (vaporize) and was not found during post flight troubleshooting
 - Current Spike was not observed in Vehicle Data due to the event duration being less than 20 ms

- Title: ET Separation Camera #1 Blown Fuse (Cont'd)
- Risk Assessment
 - No added risk to Mission success or Flight and Crew safety
- Flight Rationale
 - No electrical or mechanical discrepancies have been identified in either the vehicle hardware or the GFE Camera
 - EPD engineering has confirmed that another fuse failure in flight would not effect the function of the electrical systems
 - Loss of data from the ET Sep camera is considered a Criticality 3 failure
 - The camera and vehicle circuit have been successfully retested and are ready for flight
